**Flood Control Project Maintenance
Levee Inspections**
LMA District Cover Sheet
Spring 2009 Levee Inspection Results

Reclamation District No. 0999

Levee Inspection Report By Mile - Spring 2009

Waterway				Bank	Unit Miles	Inspection Start/End	Inspector		
Unit No. 01 Yolo Bypass				Left	15.40	03/18/2009 03/19/2009	Richard Willoughby

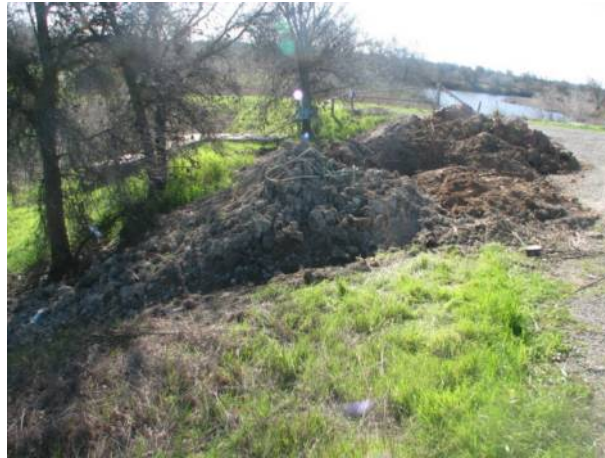
Levee Mile Report Line	6
Start Levee Mile	1.78
End Levee Mile	1.78
Location	Land Side
Category	Earthen Levee
Item	Encroachments
Material pile on waterside shoulder at LM 1.78

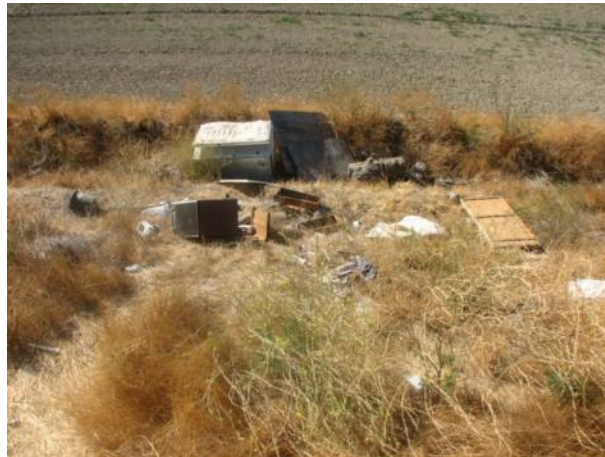
Levee Mile Report Line	15
Start Levee Mile	2.52
End Levee Mile	2.52
Location	Water Side
Category	Earthen Levee
Item	Encroachments
Garbage at waterside slope & toe.

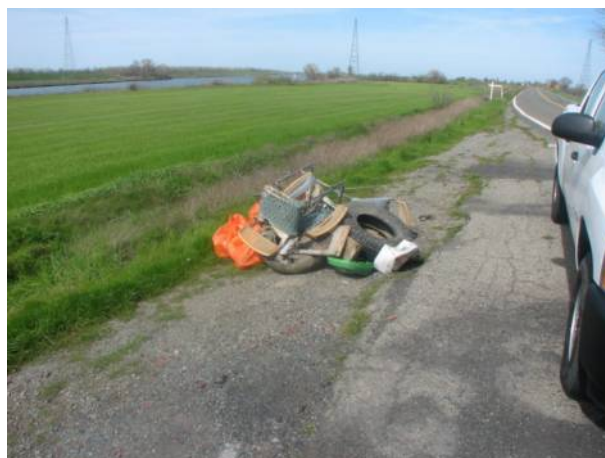
Levee Mile Report Line	15
Start Levee Mile	2.52
End Levee Mile	2.52
Location	Water Side
Category	Earthen Levee
Item	Encroachments
Garbage on waterside shoulder.

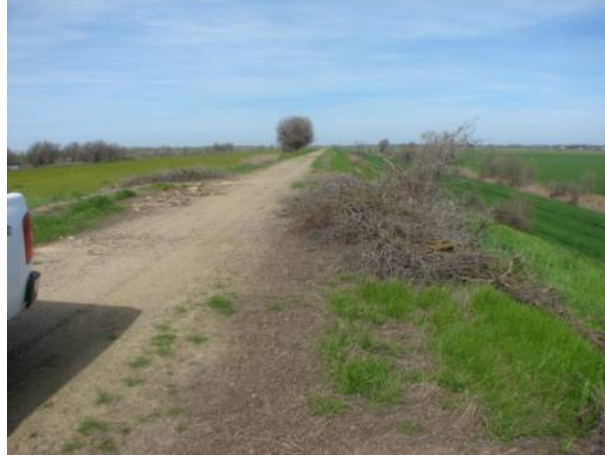
Levee Mile Report Line	17
Start Levee Mile	4.15
End Levee Mile	4.21
Location	Water Side
Category	Earthen Levee
Item	Encroachments

Pruning pile on waterside shoulder.

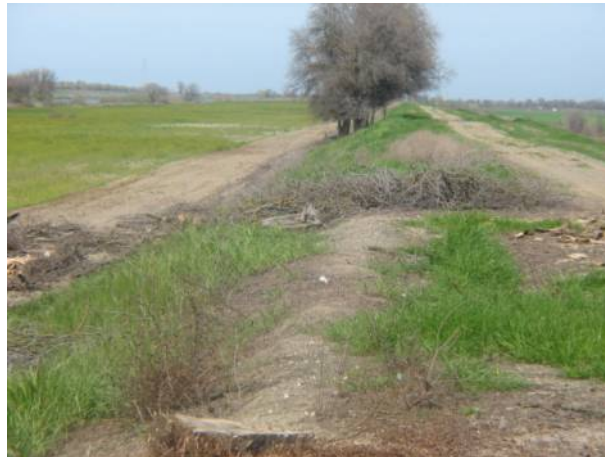
Levee Mile Report Line	18
Start Levee Mile	4.17
End Levee Mile	4.18
Location	Land Side
Category	Earthen Levee
Item	Encroachments

Prunings on waterside shoulder, slope & toe.

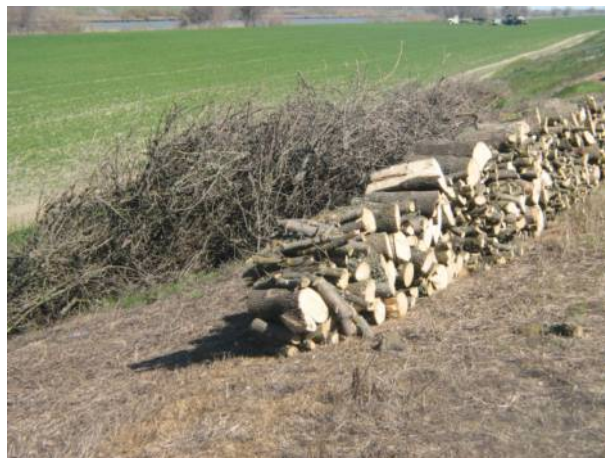
Levee Mile Report Line	20
Start Levee Mile	4.57
End Levee Mile	4.61
Location	Water Side
Category	Earthen Levee
Item	Encroachments

Pruning & Firewood pile along waterside shoulder and slope at LM 1.56

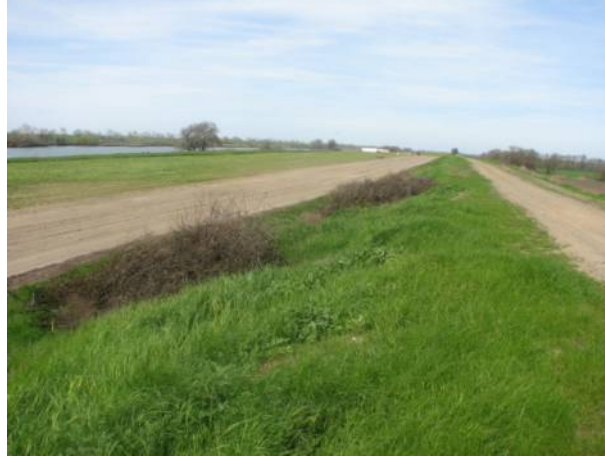
Levee Mile Report Line	20
Start Levee Mile	4.57
End Levee Mile	4.61
Location	Water Side
Category	Earthen Levee
Item	Encroachments

Prunings on waterside slope.

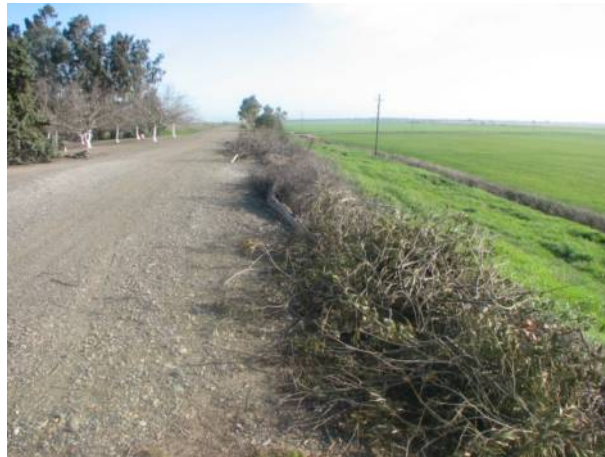
Levee Mile Report Line	24
Start Levee Mile	6.55
End Levee Mile	6.60
Location	Land Side
Category	Earthen Levee
Item	Encroachments

Prunings along landside shoulder.

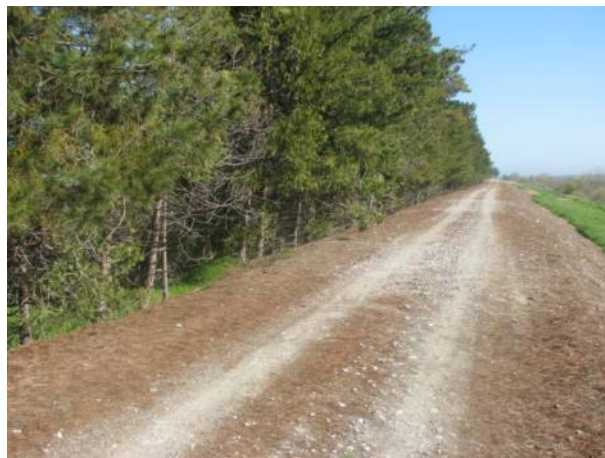
Levee Mile Report Line	31
Start Levee Mile	10.83
End Levee Mile	11.07
Location	Water Side
Category	Earthen Levee
Item	Trim / Thin Trees

Pine trees along waterside shoulder & slope. (Site of a old christmas tree farm).

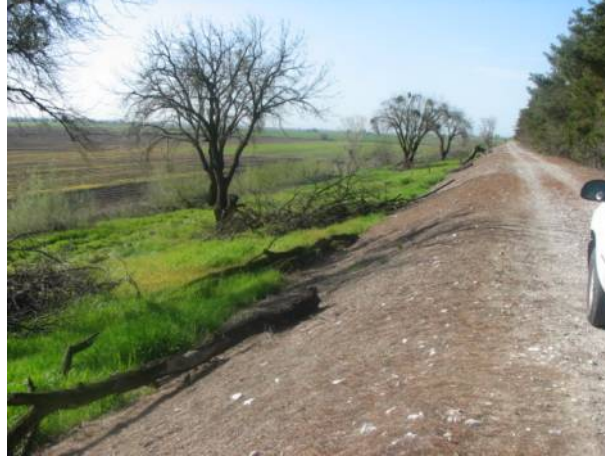
Levee Mile Report Line	32
Start Levee Mile	10.87
End Levee Mile	11.23
Location	Land Side
Category	Earthen Levee
Item	Encroachments

Tree limbs along landside slope & toe.

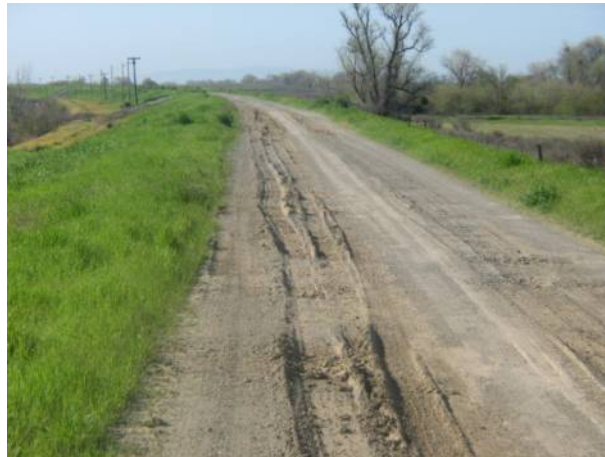
Levee Mile Report Line	33
Start Levee Mile	11.91
End Levee Mile	12.23
Location	Crown
Category	Earthen Levee
Item	Crown Surface / Depressions / Rutting

Vehicle ruts along crown road way.

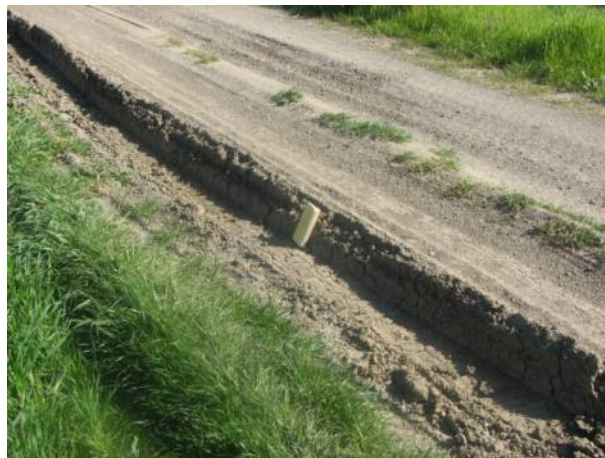
Levee Mile Report Line	35
Start Levee Mile	13.06
End Levee Mile	13.60
Location	Crown
Category	Earthen Levee
Item	Crown Surface / Depressions / Rutting

Deep (7" deep) rutting along crown roadway.

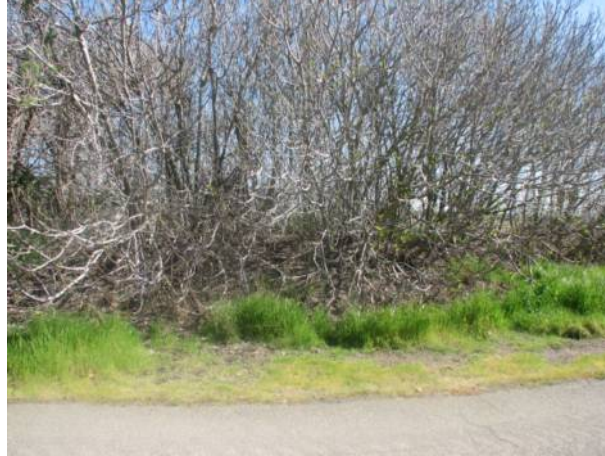
Levee Mile Report Line	14
Start Levee Mile	1.73
End Levee Mile	1.73
Location	Land Side
Category	Earthen Levee
Item	Trim / Thin Trees
Front view of overgrown fig tree on landside shoulder.

14	1.73	1.73	Earthen Levee	Trim / Thin Trees	LS M	Trim trees to at least five feet above ground level.		38.289755 ° -121.614653 °	38.289755 ° -121.614653 °	Y	23
15	1.77	1.80	Earthen Levee	Vegetation	WS M	Elderberries are blocking visibility and flood fight capability.		38.289388 ° -121.614093 °	38.289057 ° -121.613660 °		9
16	1.81	1.86	Earthen Levee	Vegetation	LS C	Remove the wild growth other than native grasses from the levee slopes.		38.289038 ° -121.613632 °	38.288784 ° -121.612721 °		10
17	2.05	2.07	Earthen Levee	Trim / Thin Trees	WS M	Trim trees to at least five feet above ground level.		38.288795 ° -121.609295 °	38.288737 ° -121.608835 °		24

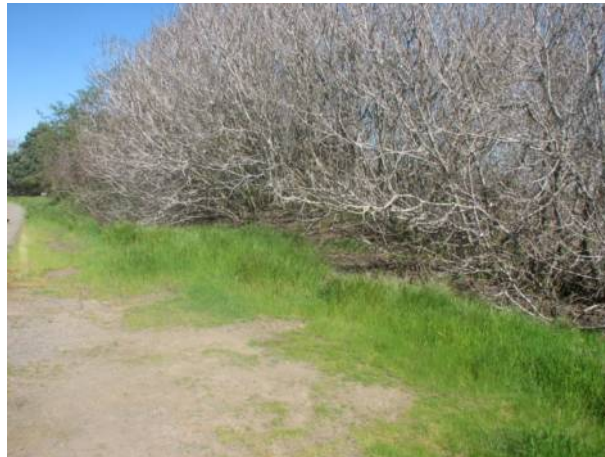
Levee Mile Report Line	14
Start Levee Mile	1.73
End Levee Mile	1.73
Location	Land Side
Category	Earthen Levee
Item	Trim / Thin Trees
Side view of overgrown fig tree along landside shoulder.

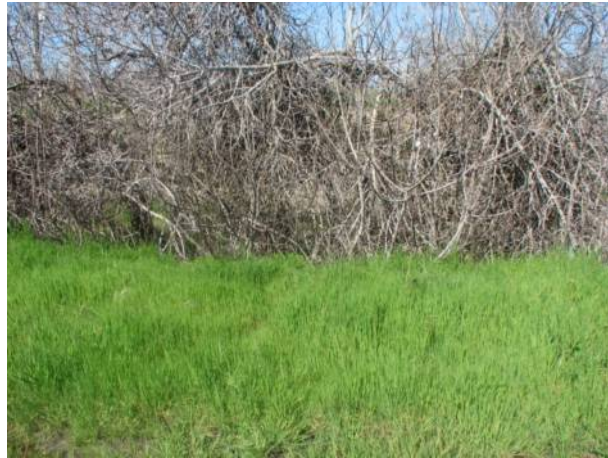
Levee Mile Report Line	2
Start Levee Mile	0.03
End Levee Mile	0.04
Location	Land Side
Category	Earthen Levee
Item	Trim / Thin Trees
Front view of overgrown trees on landside slope and toe.

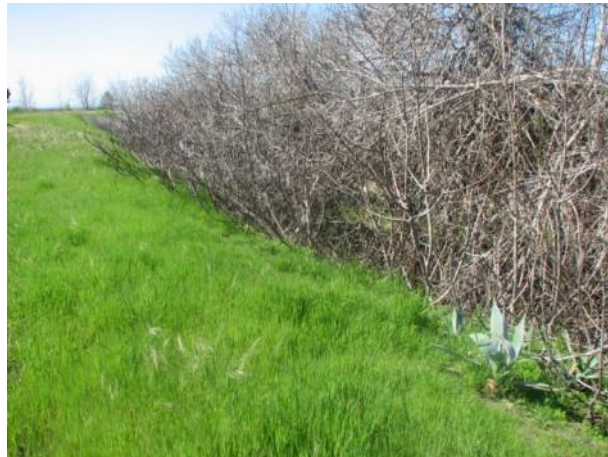
Levee Mile Report Line	2
Start Levee Mile	0.03
End Levee Mile	0.04
Location	Land Side
Category	Earthen Levee
Item	Trim / Thin Trees
Side view of overgrown trees on landside slope and toe.

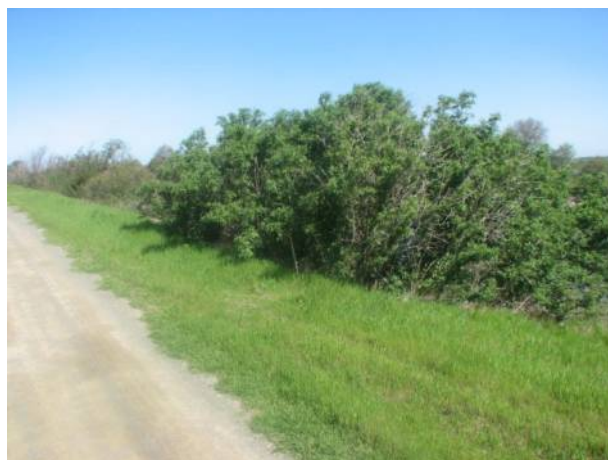
Levee Mile Report Line	7
Start Levee Mile	0.44
End Levee Mile	0.44
Location	Water Side
Category	Earthen Levee
Item	Vegetation
Elderberries blocking view of waterside slope.

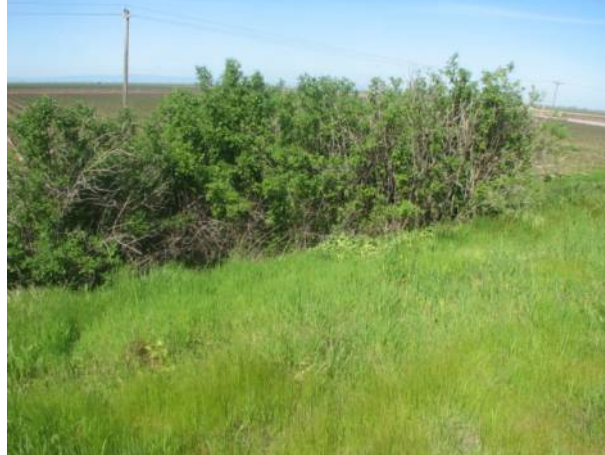
Levee Mile Report Line	8
Start Levee Mile	0.64
End Levee Mile	0.64
Location	Land Side
Category	Earthen Levee
Item	Vegetation
Elderberries blocking view of landside toe.

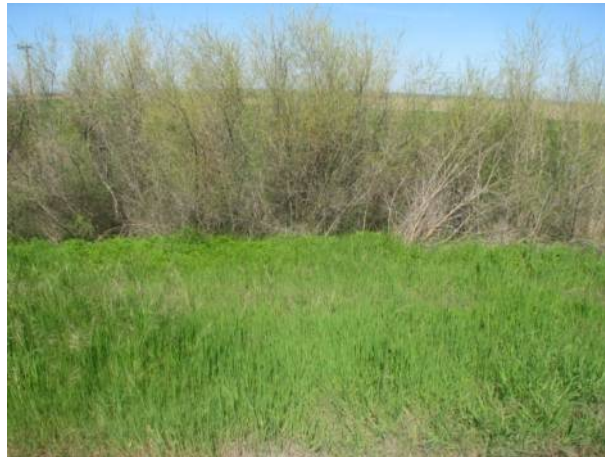
Levee Mile Report Line	15
Start Levee Mile	2.03
End Levee Mile	2.03
Location	Land Side
Category	Earthen Levee
Item	Vegetation
Front view of overgrown willow on landside toe.

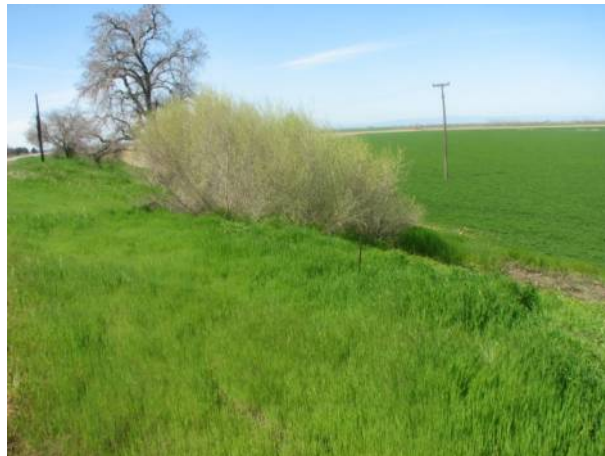
Levee Mile Report Line	15
Start Levee Mile	2.03
End Levee Mile	2.03
Location	Land Side
Category	Earthen Levee
Item	Vegetation
Side view of overgrown willow on landside toe.

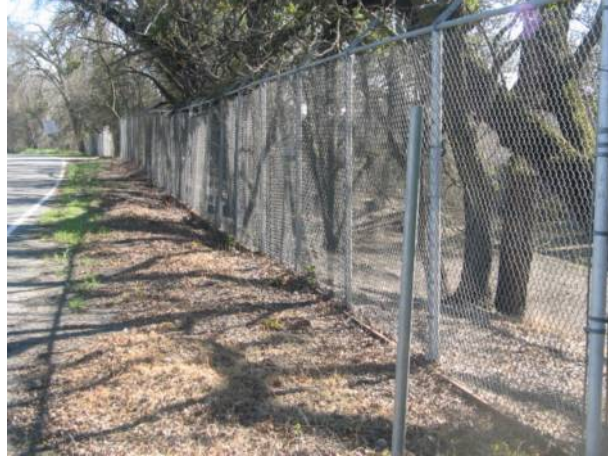
Levee Mile Report Line	3
Start Levee Mile	0.05
End Levee Mile	0.11
Location	Land Side
Category	Earthen Levee
Item	Encroachments
Cyclone fence along landside shoulder at LM 0.05 -0.11

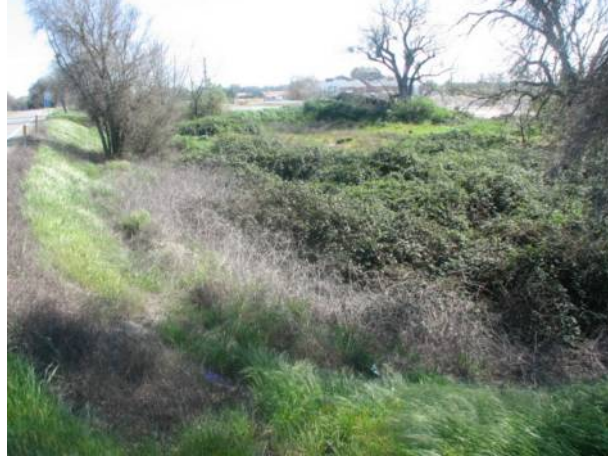
Levee Mile Report Line	1
Start Levee Mile	0.19
End Levee Mile	0.22
Location	Water Side
Category	Earthen Levee
Item	Trim / Thin Trees
Dense wild roses at landside toe (side view)

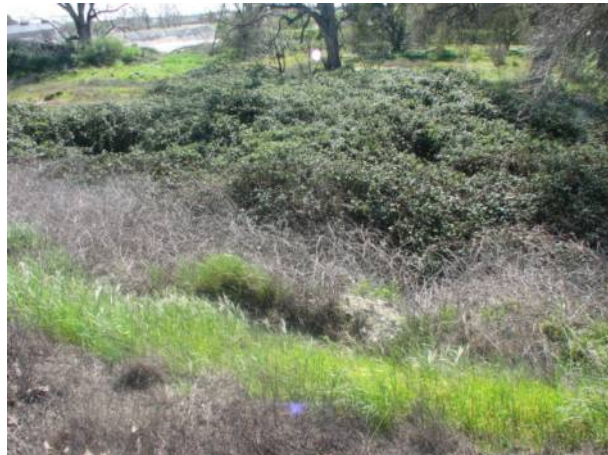
Levee Mile Report Line	1
Start Levee Mile	0.19
End Levee Mile	0.22
Location	Water Side
Category	Earthen Levee
Item	Trim / Thin Trees
Front view of dense wild roses at landside toe.

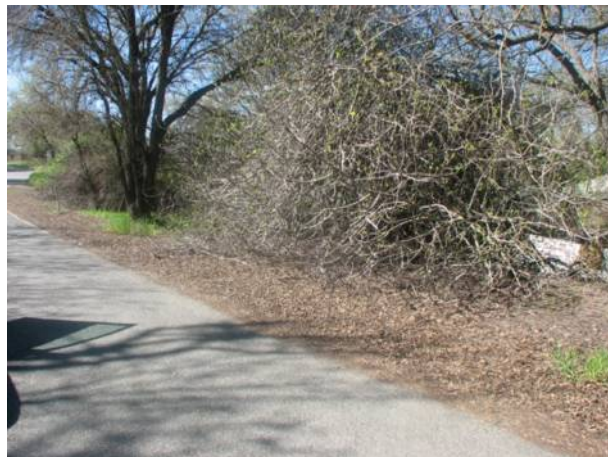
Levee Mile Report Line	10
Start Levee Mile	0.72
End Levee Mile	0.74
Location	Land Side
Category	Earthen Levee
Item	Trim / Thin Trees
Front view of dense trees at landside shoulder.

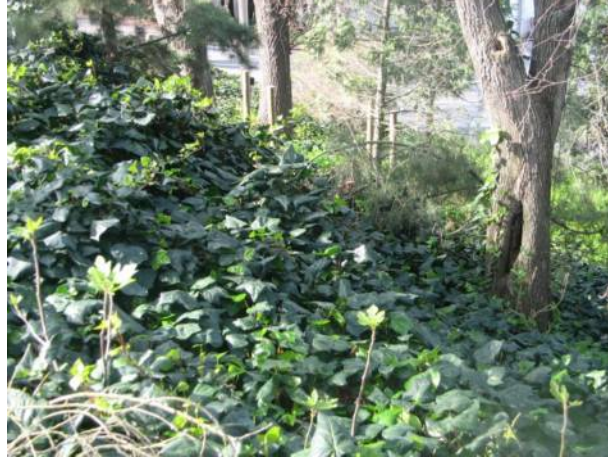
Levee Mile Report Line	12
Start Levee Mile	0.84
End Levee Mile	0.94
Location	Land Side
Category	Earthen Levee
Item	Encroachments
View of landscaping (Ivy) blocking view of landside slope from LM 0.84 to 0.94

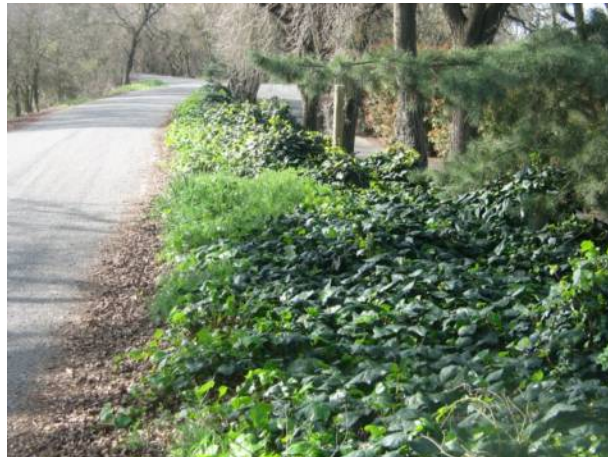
Levee Mile Report Line	12
Start Levee Mile	0.84
End Levee Mile	0.94
Location	Land Side
Category	Earthen Levee
Item	Encroachments
View of landscaping (Ivy) looking upstream from LM 0.84 to 0.94

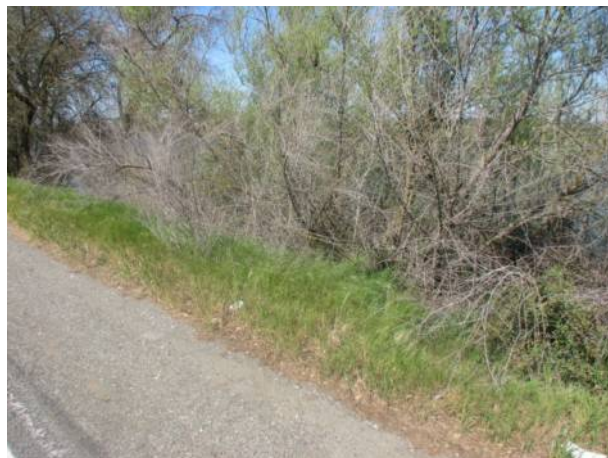
Levee Mile Report Line	18
Start Levee Mile	1.51
End Levee Mile	1.88
Location	Land Side
Category	Earthen Levee
Item	Trim / Thin Trees
Front view of dense trees along waterside slope.

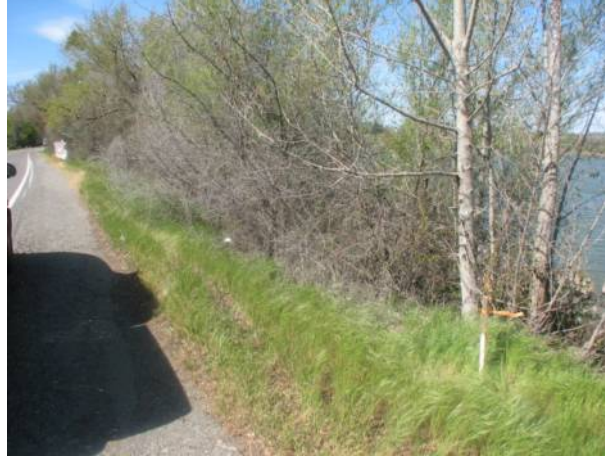
Levee Mile Report Line	18
Start Levee Mile	1.51
End Levee Mile	1.88
Location	Land Side
Category	Earthen Levee
Item	Trim / Thin Trees

Side view of dense trees along waterside slope.

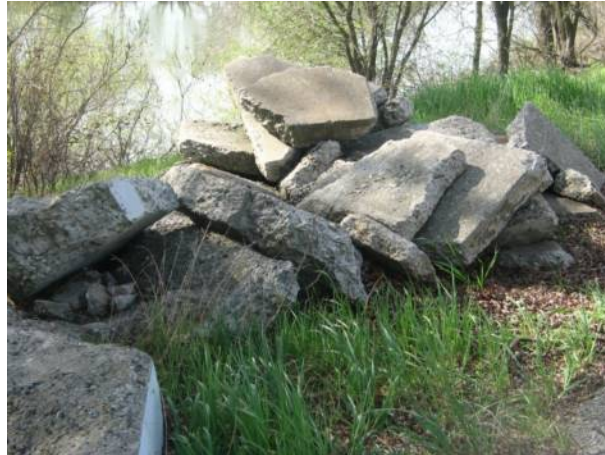
Levee Mile Report Line	24
Start Levee Mile	1.97
End Levee Mile	1.97
Location	Water Side
Category	Earthen Levee
Item	Encroachments

Concrete rubble on waterside sholder at LM 1.97

23	1.79	1.79	Earthen Levee	Vegetation	WS	U	Elderberries are blocking visibility and flood fight capability.	38.352627 ° -121.574107 °	38.352627 ° -121.574107 °		78
24	1.97	1.97	Earthen Levee	Encroachments	WS	M	Material Inspector Comments: Concrete rubble should be removed or broken up and spread out at waterward toe.	38.354888 ° -121.572540 °	38.354888 ° -121.572540 °	Y	22
25	2.06	2.06	Earthen Levee	Encroachments	WS	M	Material	38.355531 ° -121.571374 °	38.355531 ° -121.571374 °		80
26	2.12	2.14	Earthen Levee	Trim / Thin Trees	LS	M	Trim trees to at least five feet above ground level.	38.355640 ° -121.570208 °	38.355630 ° -121.569977 °		23
27	2.20	2.22	Earthen Levee	Trim / Thin Trees	LS	M	Trim and thin trees to allow visibility of the ground and room to flood fight.	38.355402 ° -121.568893 °	38.355282 ° -121.568547 °		24
28	2.65	2.70	Earthen Levee	Trim / Thin Trees	LS	M	Trim and thin trees to allow visibility of the ground and room to flood fight.	38.357371 ° -121.562500 °	38.358132 ° -121.562347 °		82

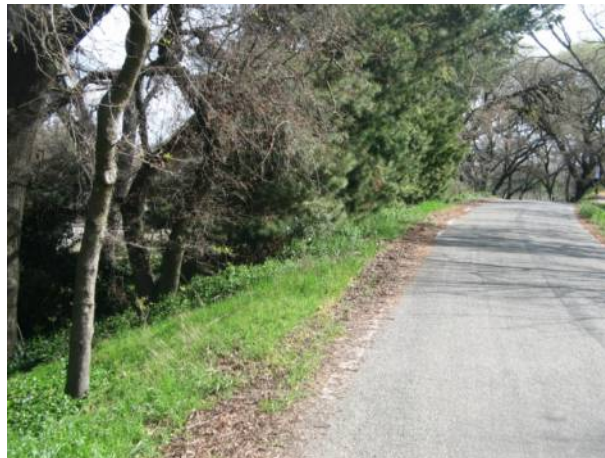
Levee Mile Report Line	31
Start Levee Mile	3.19
End Levee Mile	3.24
Location	Land Side
Category	Earthen Levee
Item	Encroachments

Looking downstream of landscaping blocking view of landside slope from LM 3.19 to 3.24

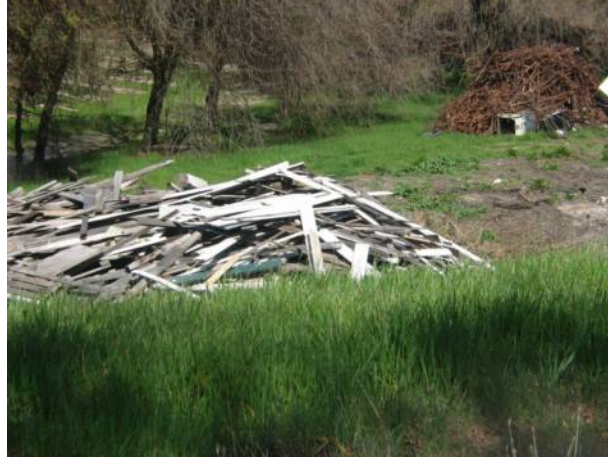
Levee Mile Report Line	42
Start Levee Mile	3.96
End Levee Mile	3.96
Location	Land Side
Category	Earthen Levee
Item	Encroachments
Garbage piles on landside toe at LM 3.96

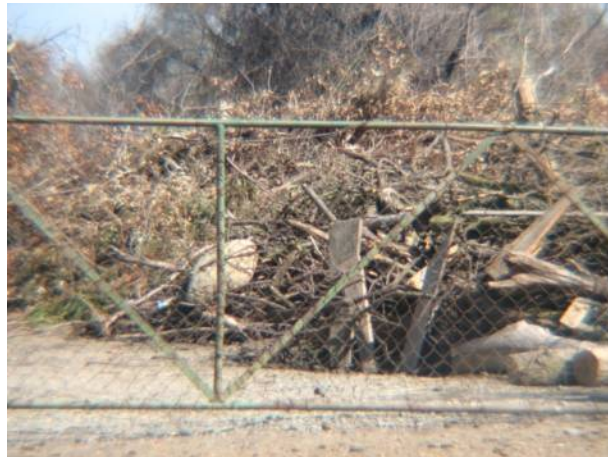
Levee Mile Report Line	45
Start Levee Mile	4.31
End Levee Mile	4.32
Location	Water Side
Category	Earthen Levee
Item	Encroachments
Pruning piles on waterward shoulder from LM 4.31 to 4.32

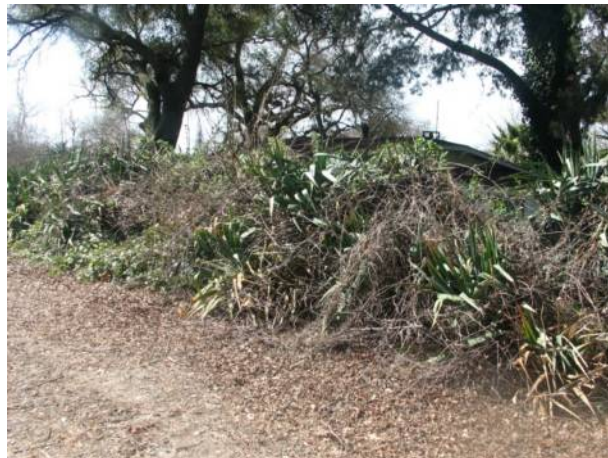
Levee Mile Report Line	46
Start Levee Mile	4.38
End Levee Mile	4.41
Location	Land Side
Category	Earthen Levee
Item	Encroachments
Overgrown landscaping on landside slope blocking view of slope from LM 4.38 to 4.41

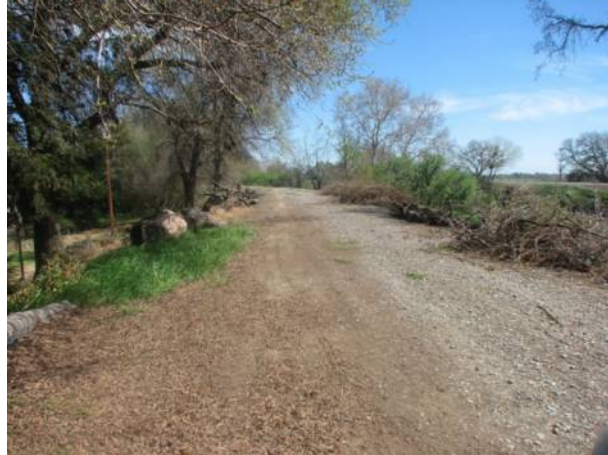
Levee Mile Report Line	52
Start Levee Mile	4.71
End Levee Mile	4.74
Location	Water Side
Category	Earthen Levee
Item	Encroachments
Pruning and firewood along landside and waterside shoulder.

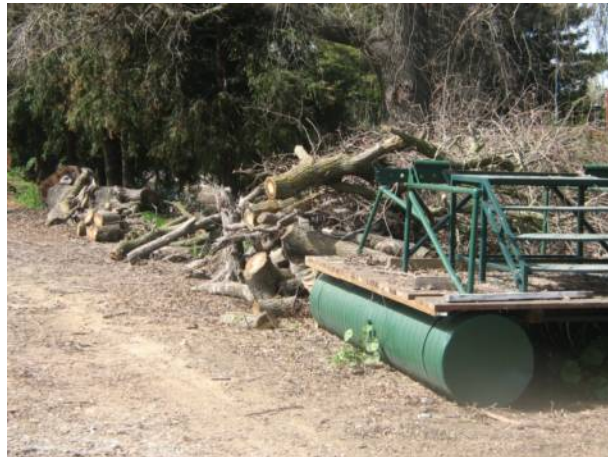
Levee Mile Report Line	53
Start Levee Mile	4.72
End Levee Mile	4.72
Location	Land Side
Category	Earthen Levee
Item	Encroachments
Prunings and firewood on landside shoulder at LM 4.72

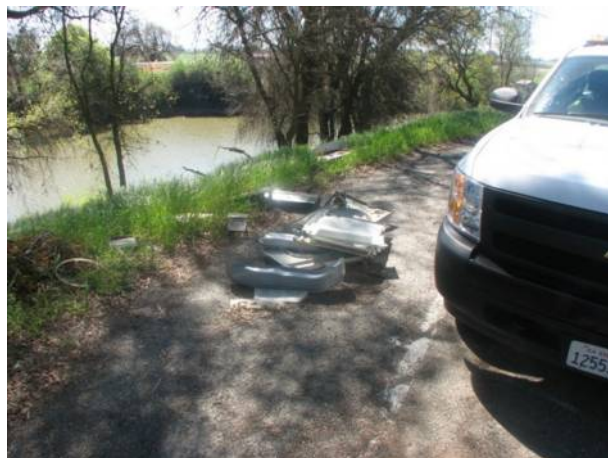
Levee Mile Report Line	56
Start Levee Mile	5.04
End Levee Mile	5.04
Location	Land Side
Category	Earthen Levee
Item	Encroachments
Garbage at waterside shoulder and crown.

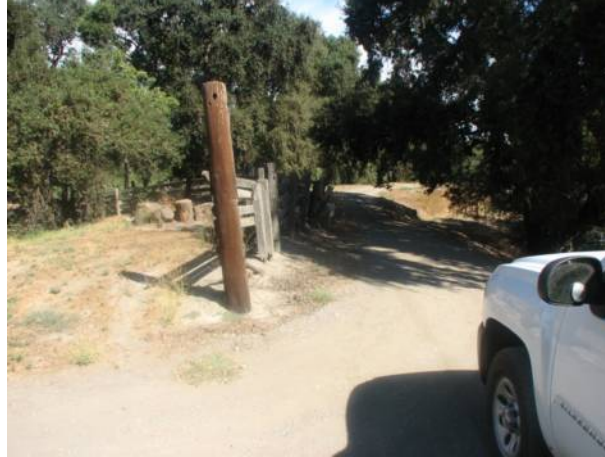
Levee Mile Report Line	68
Start Levee Mile	6.83
End Levee Mile	6.83
Location	Land Side
Category	Earthen Levee
Item	Encroachments

Fence and Firework at landside shoulder.

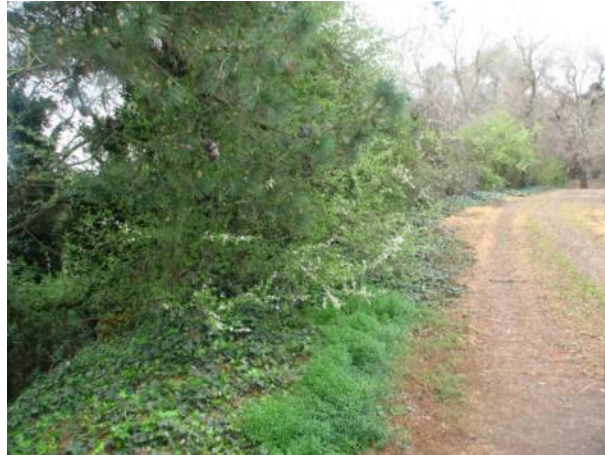
Levee Mile Report Line	73
Start Levee Mile	7.65
End Levee Mile	7.69
Location	Land Side
Category	Earthen Levee
Item	Encroachments

Landscaping on landside slope blocking view of slope from LM 7.65 to 7.72

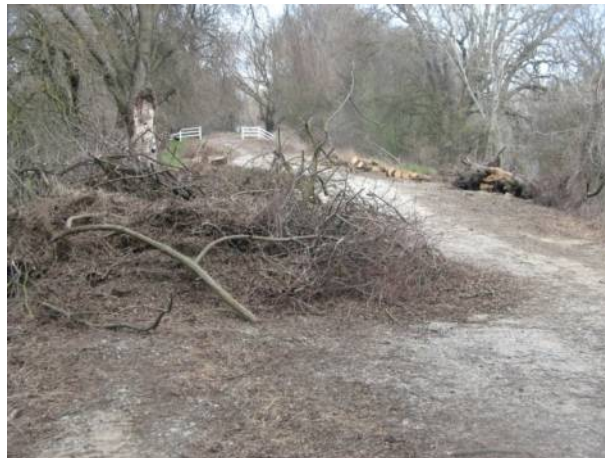
Levee Mile Report Line	78
Start Levee Mile	8.51
End Levee Mile	8.51
Location	Water Side
Category	Earthen Levee
Item	Encroachments

Prunings and firewood on waterside and landside shoulder at LM 8.51

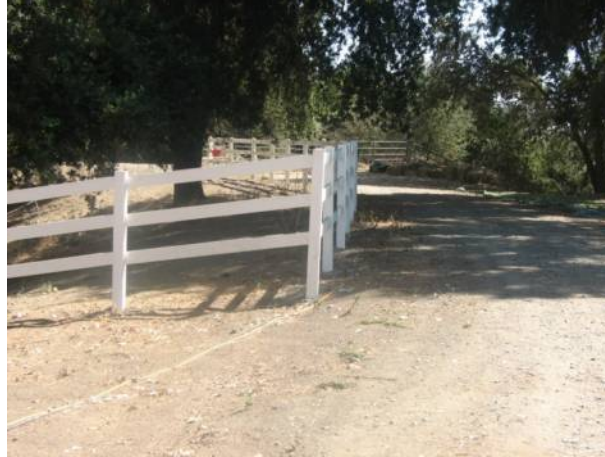
Levee Mile Report Line	79
Start Levee Mile	8.57
End Levee Mile	8.61
Location	Land Side
Category	Earthen Levee
Item	Encroachments
New installed unauthorized fence at landside slope and shoulder.

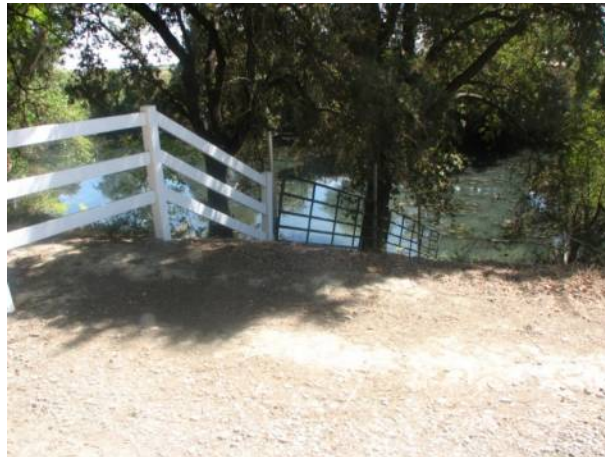
Levee Mile Report Line	82
Start Levee Mile	8.72
End Levee Mile	8.72
Location	Crown
Category	Earthen Levee
Item	Encroachments
New unauthorized fence that extend from landside toe to waterside toe.

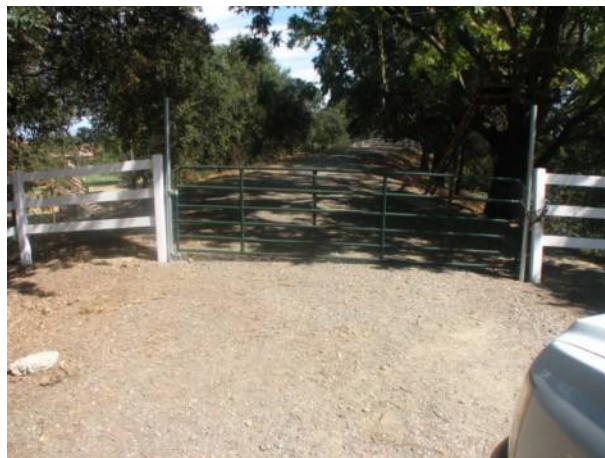
Levee Mile Report Line	82
Start Levee Mile	8.72
End Levee Mile	8.72
Location	Crown
Category	Earthen Levee
Item	Encroachments
View of fence & gate across levee crown, landside & waterside slope.

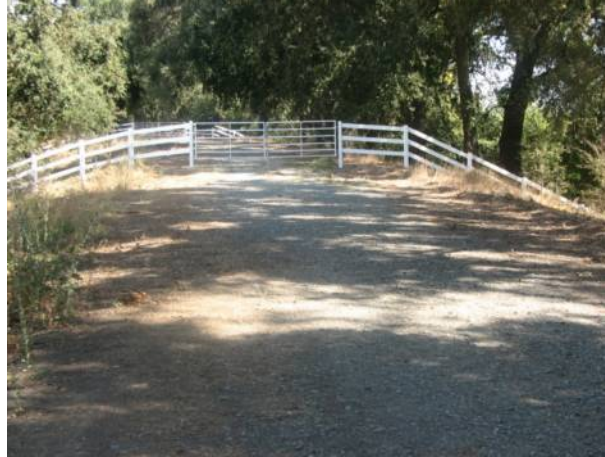
Levee Mile Report Line	83
Start Levee Mile	8.78
End Levee Mile	8.78
Location	Crown
Category	Earthen Levee
Item	Encroachments
New unauthorized fence and gate that extend from landside toe across levee crown to waterside toe.

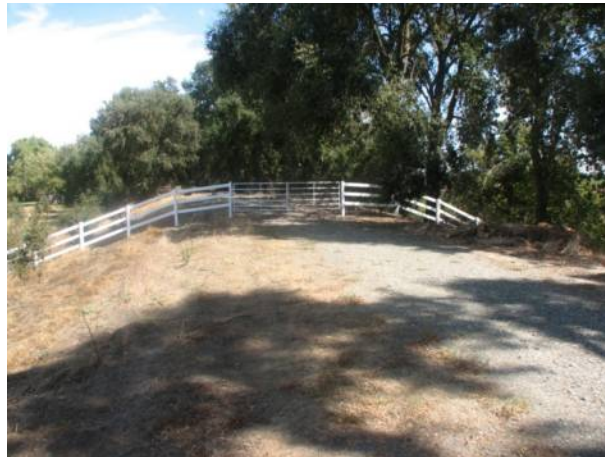
Levee Mile Report Line	85
Start Levee Mile	8.81
End Levee Mile	8.81
Location	Crown
Category	Earthen Levee
Item	Encroachments
New unauthorized fence and gate that extend from landside toe across levee crown to waterside toe.
